Original Article

Experimental investigation of a sustainable reinforced cantilever concrete slab exposed to different intensity of temperatures

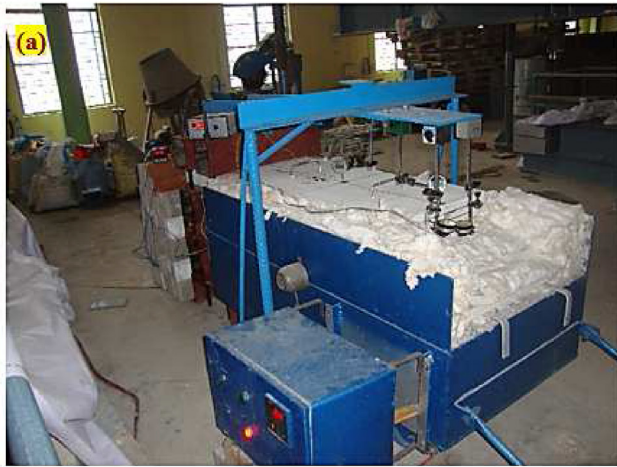
Fig. 2 – (a) Slab heating setup (b) Time – Temperature curve of furnace.

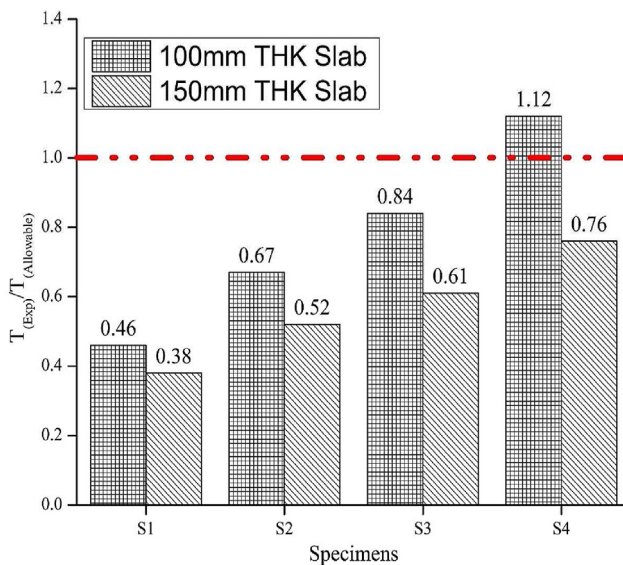
Fig. 10 – Insulation check for 100 mm and 150 mm thick concrete slab.

Two different sets of failure criteria, both based on insulation, were proposed by a Eurocode (as a function of Separating) [55]. It is found that when any of the following criteria are met, it is considered that a slab has failed: (i) The non-exposed surface can only experience an increase in temperature of 140 °C on average, (ii) The temperature at the non-exposed surface of the slab should not be greater than are equal to 180 °C at any point on the non-exposed surface. Fig. 10 depicts insulation checks for 100 mm and 150 mm thick slabs. The S4 of the 100 mm slab exceeds the specified limit for insulation. S1, S2, and S3 of 100 mm thick slab and all the specimens of 150 mm thick slab show satisfactory performance over insulation criteria.

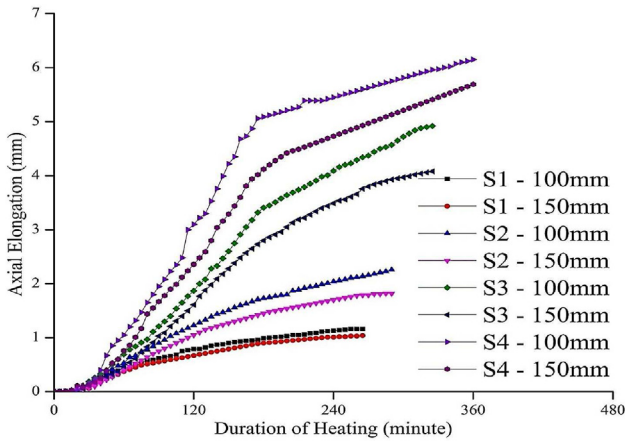
Fig. 13 – Axial elongation of 100 mm thick and 150 mm thick slab during the heating stage.

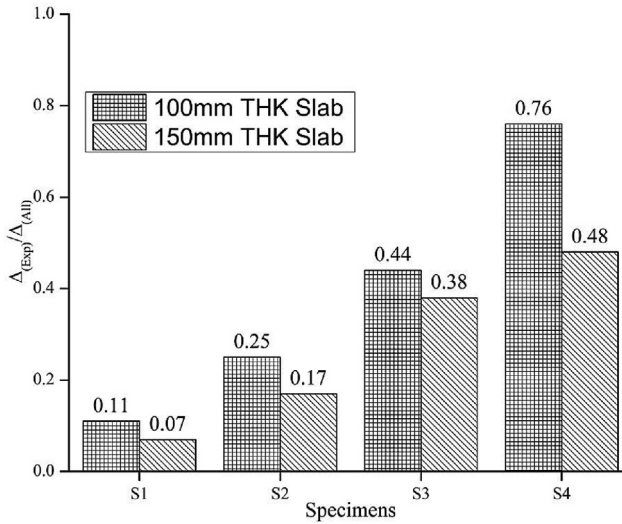
Fig. 15 – The ratio of ultimate deflection during the heating phase to BS-476 [37] recommends various thicknesses and high temperatures.

During the heating phase, the final deflection observed was compared to the allowed deflection parameters, as shown in Fig. 15. The ultimate deflections of the slabs were found to be within the limit specified. The deflection rate for different cooling conditions calculated during the cooling phase is shown in Fig. 16 (a) and (b) have not exceeded the failure criteria specified (see Fig. 16).

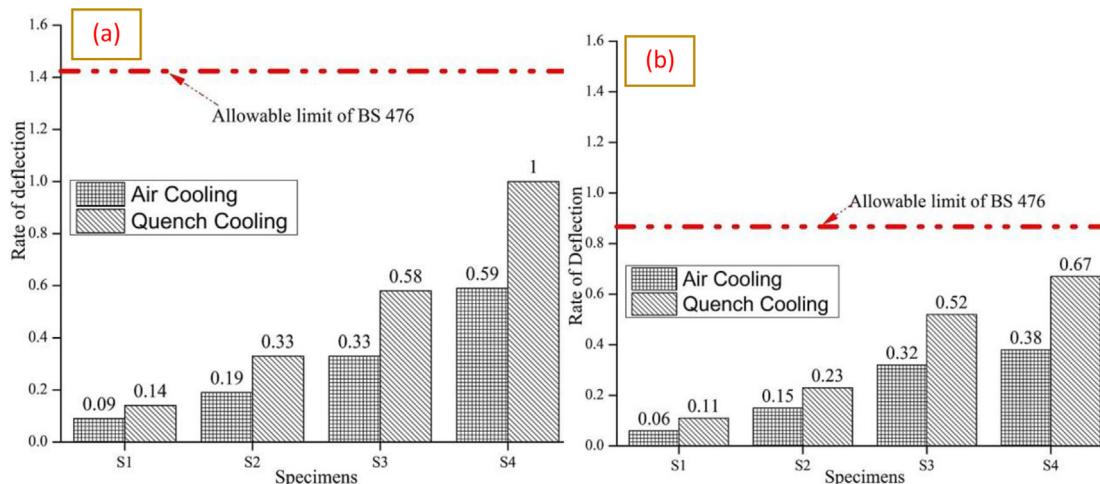
Fig. 16 – Comparison of deflection rate provided in BS-476 [37] and experimental results (a) 100 mm thick slab (b) 150 mm thick slab.

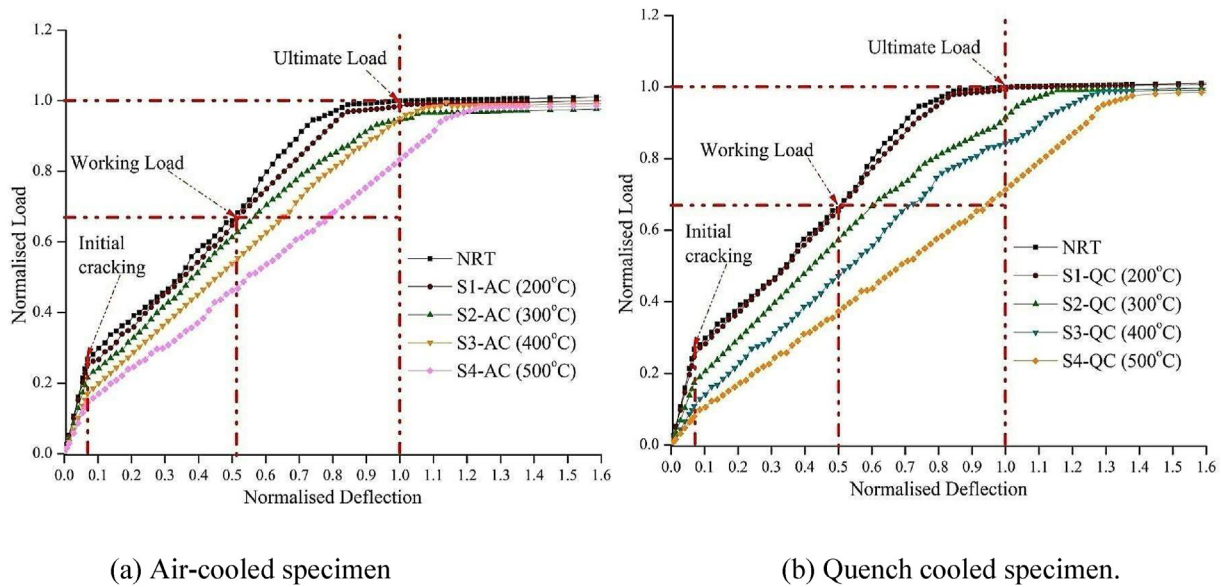
Fig. 17 – Normalized load versus displacement of 100 mm thick concrete slab (a) air-cooled specimen (b) quench-cooled specimen.

The assessment of residual strength and residual stiffness of fire-affected reinforced concrete elements is essential to decide whether they can be repaired or demolished. Fig. 17 (a) and (b) provide a detailed load versus deflection behavior of

heat-affected 100 mm thick concrete specimens, which were air-cooled and quench-cooled, respectively. The graph indicates that the initial cracking load decreases for slabs exposed to higher temperature magnitude. Most slabs had a defined initial cracking load except for quench-cooled specimens exposed to 400 °C and 500 °C. This effect was due to the extensive cracks formed at the top of the slab resulting from quenching, as shown in Fig. 11 (c), 12 (c) and (d). The working load and ultimate load of slabs exposed to various temperatures matched the normal specimen, but the deflection for specific loads varies based on exposed temperature and cooling conditions.

Fig. 17 (a) and (b) indicate that the structure that deforms during heating and regains its original position during cooling has a definite loss in flexural stiffness of the specimens. The quantity of reduction in flexural stiffness depends on the thickness of the slab, exposed temperature and cooling conditions [10,11,60]. Compared to the thicknesses of the slab, the loss in flexural stiffness is less for the thicker slab for all the exposed temperatures, as shown in Fig. 18 (a) and (b). In the case of 200 °C, the reduction in flexural stiffness is very meager for both the thickness of the slab and for two different cooling conditions. The percentage reduction in flexural stiffness for 100 mm thick slab was 10.56%, 21.76% and 35.52% for 300 °C, 400 °C and 500 °C, respectively for air-cooled specimens. Similarly, for quench cooled conditions, the percentage loss in stiffness was 16.48%, 30.0% and 45.92% for 300 °C, 400 °C and 500 °C, respectively.

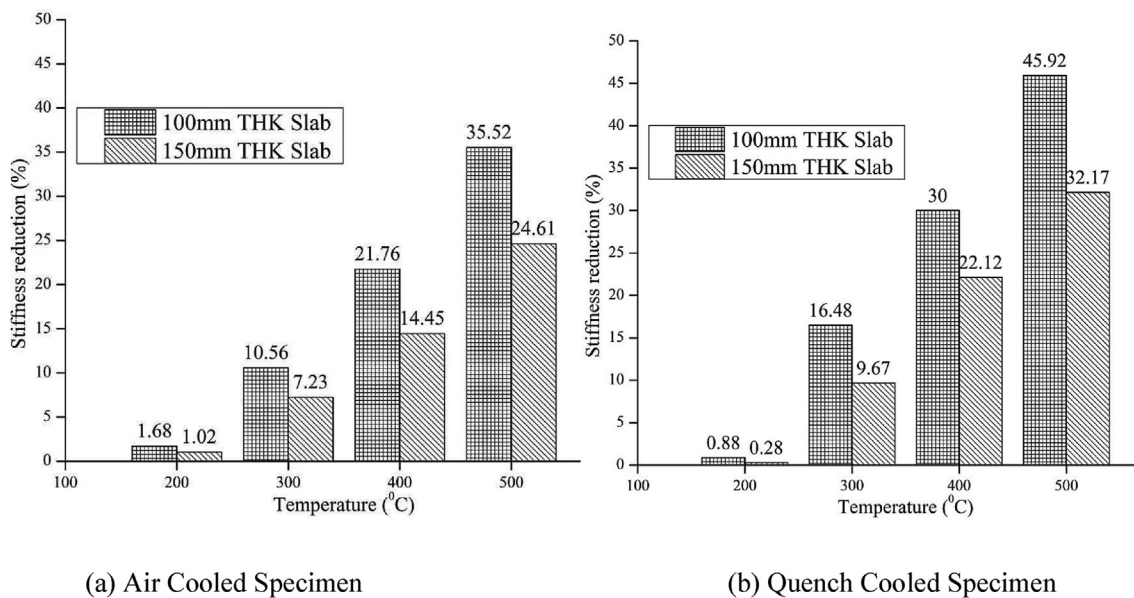
Fig. 18 – Percentage reduction in flexural stiffness after exposure to various temperatures a) air-cooled specimen b) quench-cooled specimen.

temperature and the loss percentage of flexural stiffness was maximum for slabs exposed to a temperature of 500 °C. The additional loss percentage of flexural stiffness in 100 mm thick slab for quench-cooled conditions were 5.92%, 8.24% and 10.36% compared to the air-cooled specimen for 300 °C, 400 °C and 500 °C, respectively. In the case of a 150 mm thick slab, the loss percentages were 7.23%, 14.45% and 24.61% for air-cooled specimens. In the quench-cooled specimen, the loss in stiffness was 9.67%, 22.12% and 32.17% for 300 °C, 400 °C and 500 °C, respectively. The additional percentage losses in stiffness for 100 mm thick slab compared to 150 mm thick slab were 3.3%, 7.26% and 10.91% for 300 °C, 400 °C and 500 °C, respectively, for the air-cooled specimen. In the case of

quench-cooled specimens, it was 6.81%, 7.88% and 13.75% for 300 °C, 400 °C and 500 °C, respectively. The loss in stiffness of the quench-cooled members was more than that of the air-cooled specimens due to thermal shock action and coarsening of pores [40–42,44].

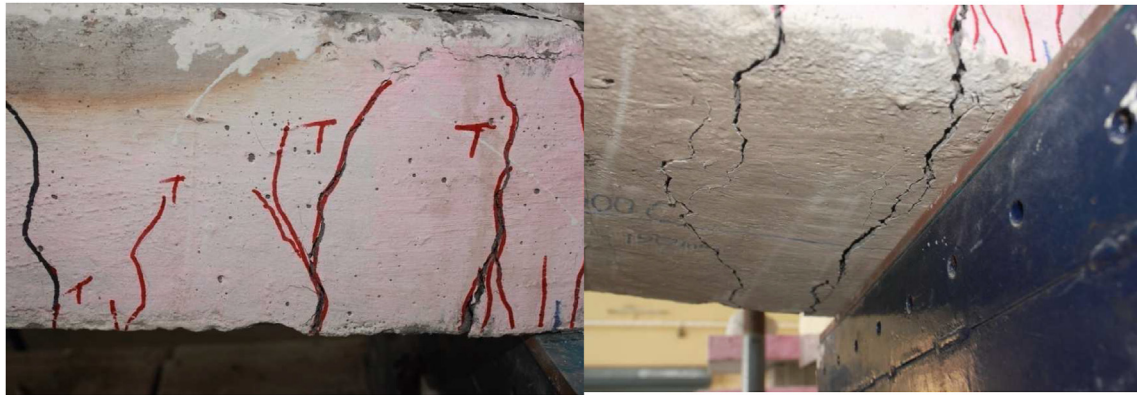
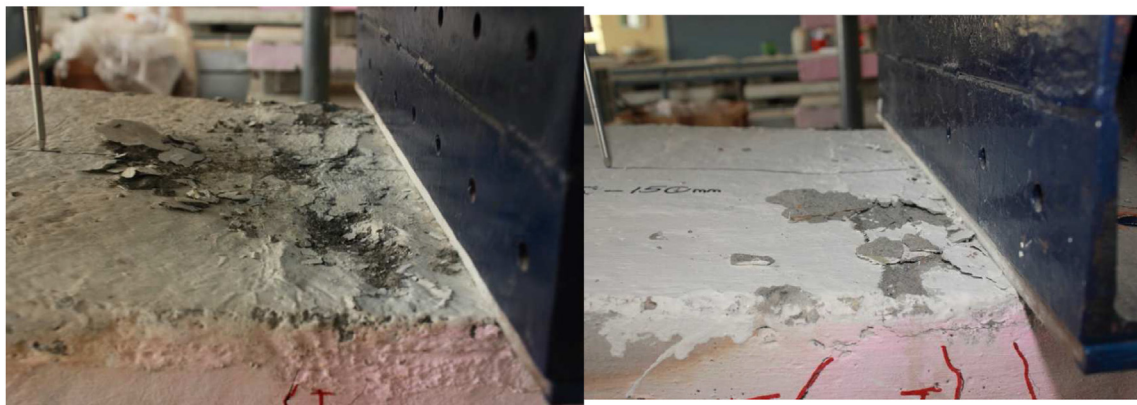
a) Cracking of Specimen in the tension zone under mechanical loading

b) Initiation of Compression Failure in the Concrete Specimen under Mechanical Loading

Fig. 19 – Failure pattern of thermally exposed concrete Slabs under mechanical loading.

The cracking and crushing of concrete at the fixed end during the mechanical loading are shown in Fig. 19 (a)–(d). The initial cracks developed at the maximum moment zone, and as the test continued, some cracks that were formed already due to heating and cooling between supports to half the length of the member widened [10,12]. Cracks developed to the full depth of the slab, as shown in Fig. 19 (a), were found in all the slabs. The crushing failure of concrete was witnessed

in S3-(D&Q)-100, S4-(D&Q)-100, S3-Q-150 and S4-150-(D&Q). In S2-Q-100 and S3-D-150, out of three slabs, one slab initiated the crushing failure of concrete.
